# **2006 ANNUAL REPORT**

## **BIOLOGICAL OPINION ON THE OPERATION OF THE MISSOURI RIVER MAIN STEM SYSTEM, MISSOURI RIVER BANK STABILIZATION AND NAVIGATION PROJECT, AND OPERATION OF THE KANSAS RIVER RESERVOIR SYSTEM**

Prepared By:  
U.S. Army Corps of Engineers  
Omaha District  
Kansas City District

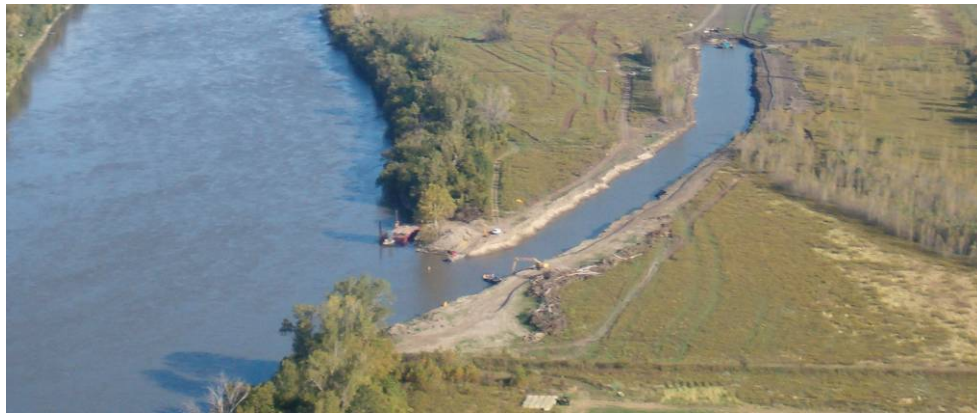
Rush Bottoms Chute, RM 502, Left Bank. A contract for construction of a 75 feet wide and 10,000 feet long chute at Rush Bottoms was awarded in mid-summer. The contractor chose to excavate the chute by hydraulic dredge. By the end of September 2006, the bottom 1,500 feet of the chute was fully excavated. The contractor plans to suspend dredging during the winter when stages are low and resume dredging in the spring. A picture of the lower 1,500 feet is shown below.

Photograph 3. Rush Bottoms Chute, RM 502

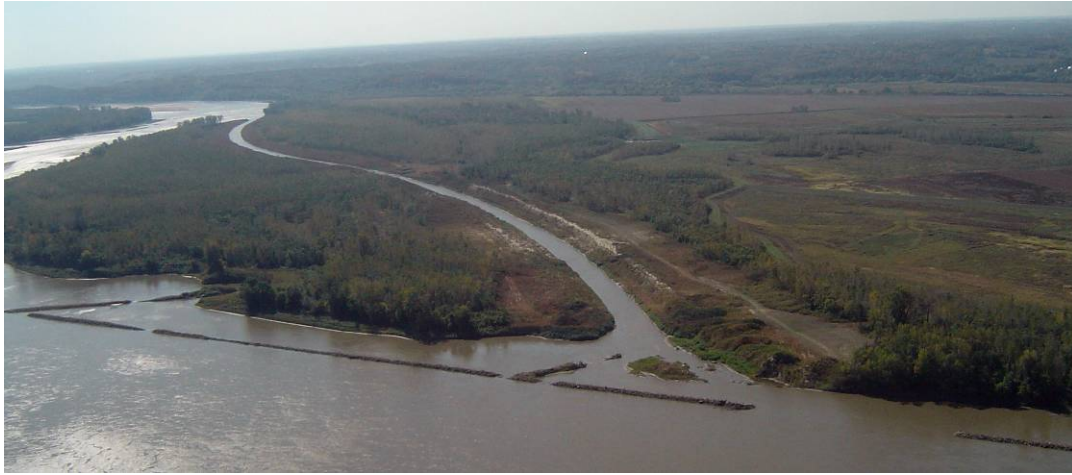
Tadpole Island Chute, RM 175, Right Bank. An 80 feet wide and 9,800 feet long chute was constructed during the winter by in-house work crews at Tadpole Island. The chute is located at the downstream end of Overton Bottoms which is owned by the Corps and managed by MDC. Spoils were placed along the sides of the chute and coarsely graded. It is anticipated that as the chute widens the spoils will slough into the chute and be transported out into the river by flows through the chute.

Photograph 4. Tadpole Island Chute, RM 175

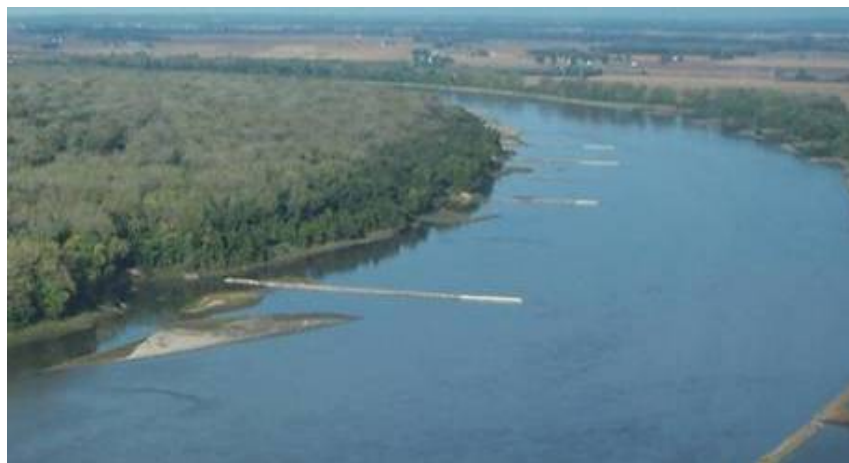
Pelican Island Dike Extensions and Notching, RM 18, MDC. Ten dikes around Pelican Island were extended and notched. This work was included as two line items in the FY 2006 river structure maintenance contract. The riverward end of the dikes was extended 50 feet to 100 feet and the landward portion of the same dikes was notched 100 feet to 150 feet. In addition to creating habitat, the notches ensure the extensions do not adversely affect flow conveyance. Similar dike extensions and notching constructed at Lisbon during 2004 resulted in significant submerged sandbar formation downstream of the extensions and creation of secondary channels near the bank. The resulting habitat had a high degree of diversity and complexity. In FY 2007, an additional 10 dikes at Howell Island (RM 45) will be extended and notched as part of this contract.

Photograph 5. Pelican Island Dike Extensions and Notching, RM 18

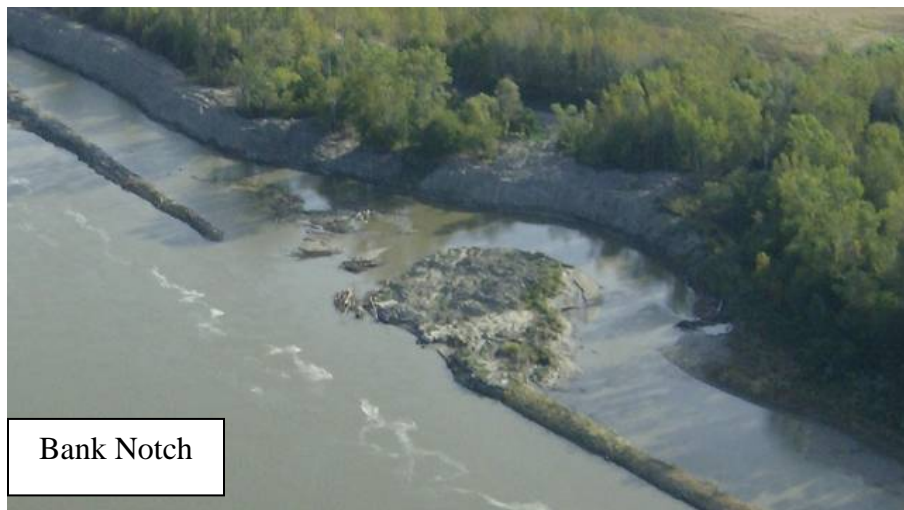
Bank Notch and Revetment Chute Construction at Wolf Creek, RM 480, Left Bank. District in-house work crews constructed 11 bank notches and one 3,200 feet long revetment chute at Wolf Creek Bend. The property was purchased by the Corps and is currently managed by the MDC. Over 350,000 cubic yards of material were excavated for the project with all material disposed of directly into the river. Resulting bank notches are 75 feet wide excavated down to 3 feet below minimum navigation stages. The revetment chute has a bottom width of 100 feet and was excavated to 4 feet below minimum navigation stages. Lessons

learned from previous bank notch and revetment chute construction were incorporated into the design and construction.

Photograph 6. Bank Notch Construction at Wolf Creek, RM 480

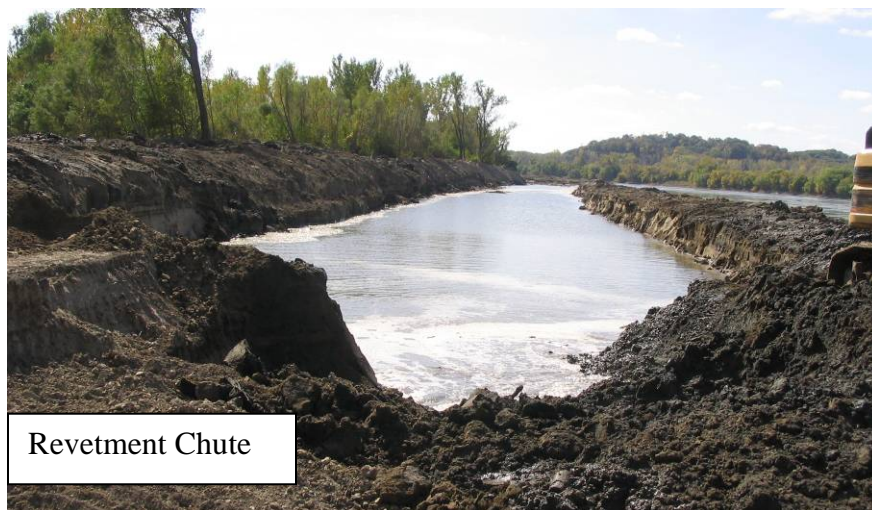
Photograph 7. Revetment Chute Construction at Wolf Creek, RM 480

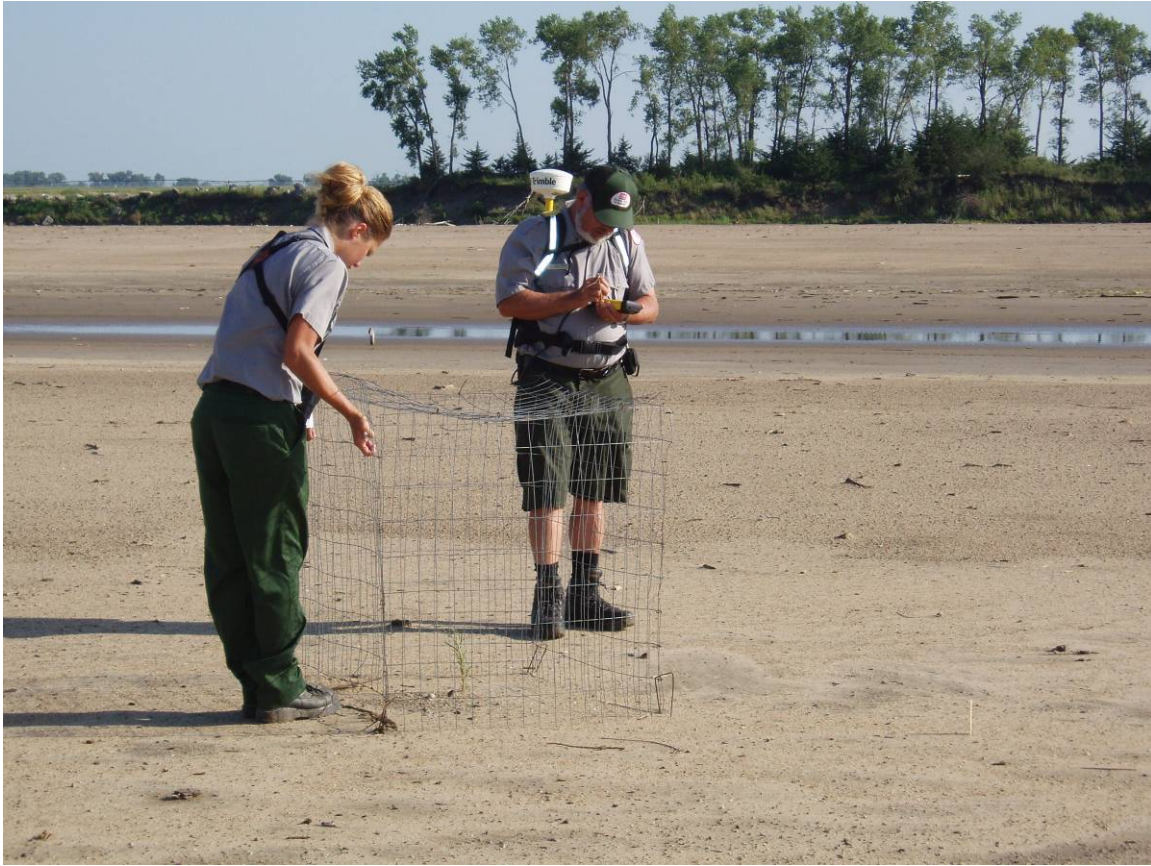
Wire mesh cages were used in 2006 to protect piping plover nests from mammalian and avian predators. The cages consist of three feet by three feet by three feet wire mesh containing two-by-four-inch openings (See Photograph 12). The cages are placed over the plover nest and anchored into the substrate with metal stakes at the four corners. After placing the cage, the surveyors retreat and watch the cage to ensure that the plover returns to the nest inside the cage. If the plover refuses to enter the cage, the cage is removed. When a nest is terminated the cage is removed.

Photograph 12. Gavins Point Crew installing a Plover Cage
